Feasibility Appraisal  
in respect of  
The Subway  
at the  
Royal Shrewsbury Hospital  
for and on behalf of  
The Shrewsbury and  
Telford Hospital  
NHS Trust

August 2015

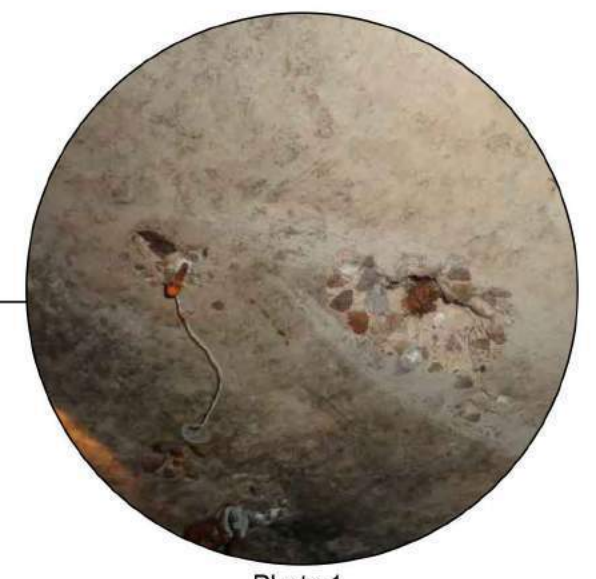
Photo 1 - Localised Spalling

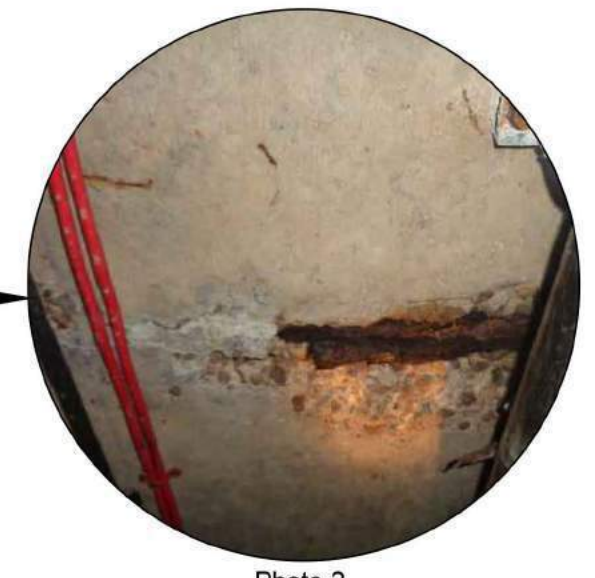
- 2.4 If we consider each section of the subway in turn, it can be observed via photograph 2 in Appendix A that severe spalling and corrosion of the reinforcement is apparent to the soffit of the roof section in isolated locations within section 1 nearest the boiler house. Similarly, in section 2 via photographs 4, 5 and 6 it is clear where there is insufficient cover to the reinforcement and the carbonation process has caused significant spalling.

Photo 2 - Localised Spalling and exposure of rebar

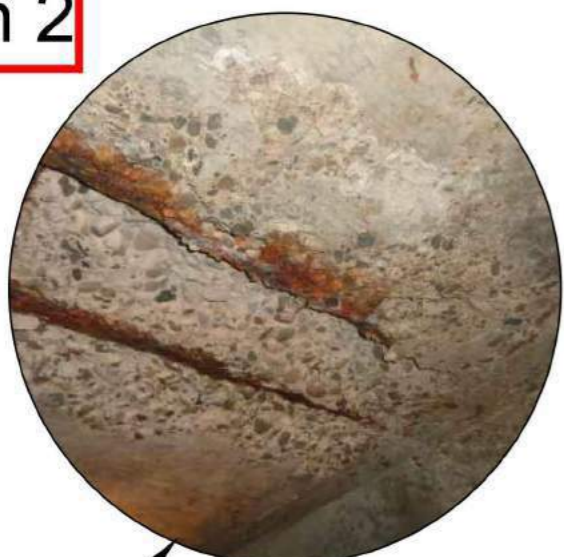
Photo 4 - Localised rebar exposure due to insufficient cover

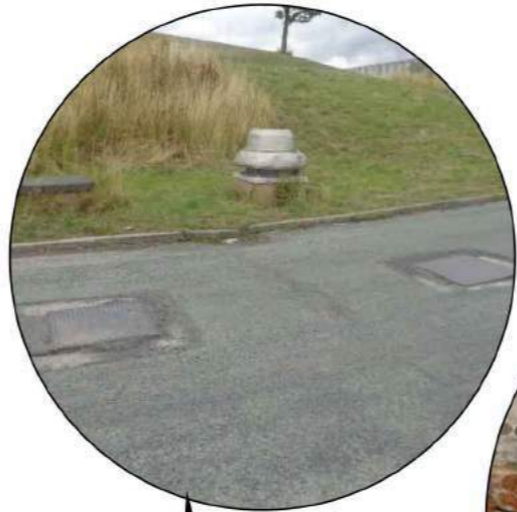
- 2.5 Photograph 51 shows access chambers to the roof of Section 2 which are located in the service road between the boiler house and Estates Department (Appendix B). The same photograph show air vents within the verge which were introduced when the subway was extended between the boiler house and main building (section 4). There is a distinct lack of natural ventilation in sections 1, 2, 3 and 9 which form the original part of the below ground duct/subway.

Photo 51 - Access point to boiler house road

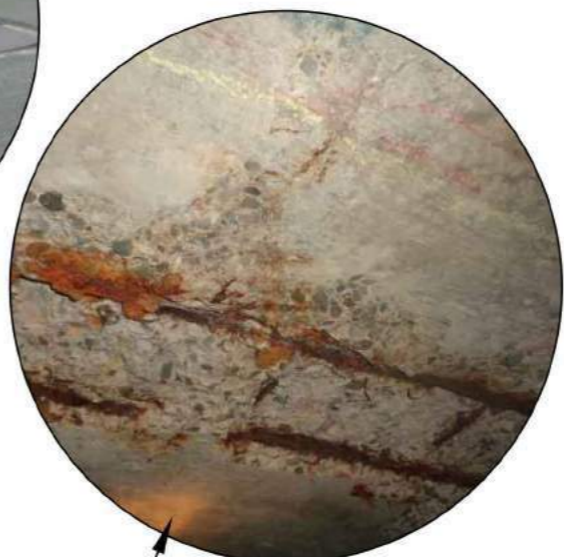
Photo 5 - Localised rebar exposure due to insufficient cover

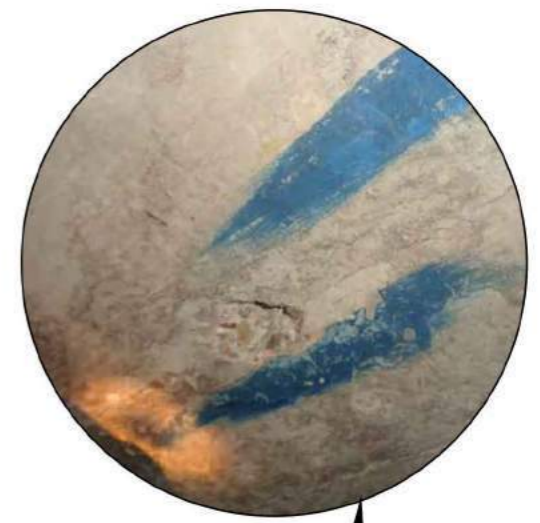
Photo 6 - Localised Spalling

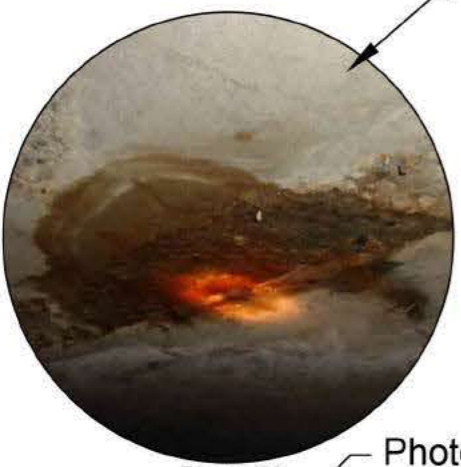
Photo 12 - Localised spalling to roof of duct

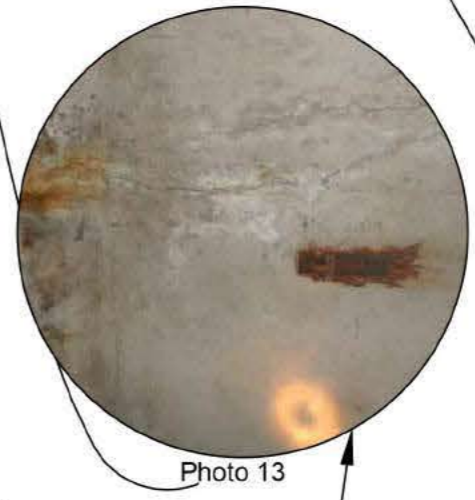
Photo 13 - Localised spalling / cracking to roof/walls

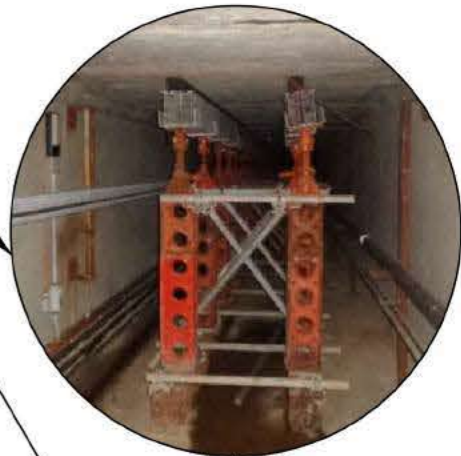
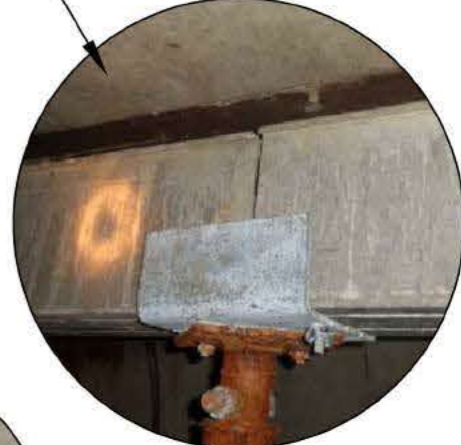
Photo 10 & 11 - Temporary support under staff car park

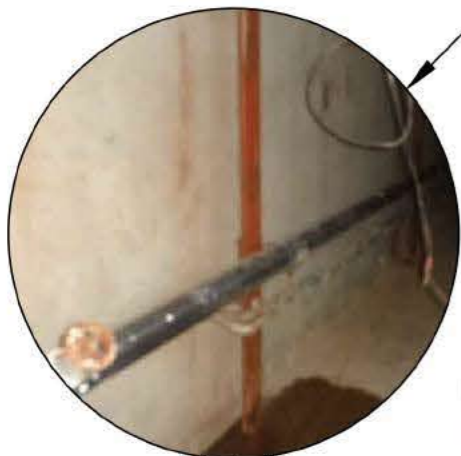
Photo 14 - Rusting Support system

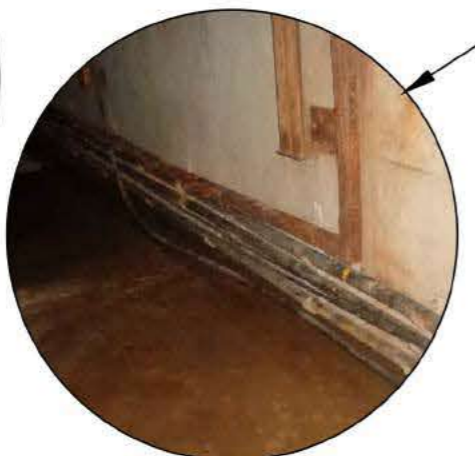
Photo 17 - mains cables at low levels

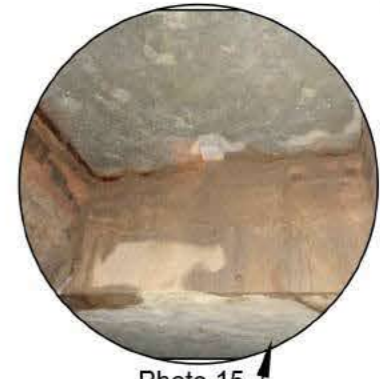
- 2.11 At the junction of sections 3 and 9 of the subway a further access hatch is provided. This is shown on photograph 50 of Appendix E and photograph 15 of Appendix D where the subway roof only measures about 350mm in thickness.

Photo 15 - Underside of access hatch

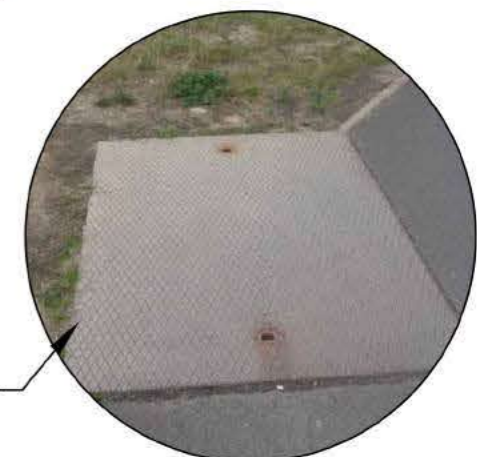
Photo 50 - Access point under footpath

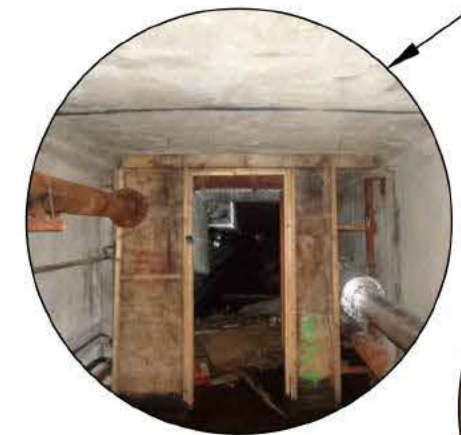
Photo 20 - Poor fire barrier

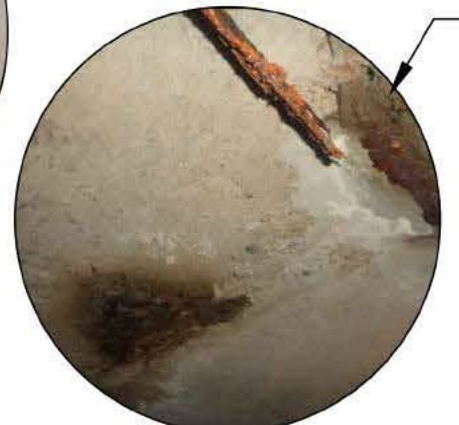
Photo 21 - Poor Movement joint to roof

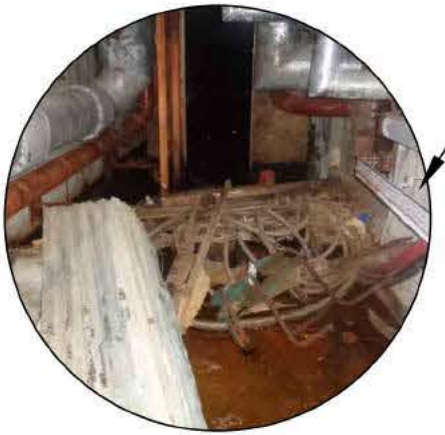
- 2.10 Photograph 22 of Appendix E shows a large deposit of general debris which has accumulated at the junction with the subway leading to pathology. This requires removal immediately and is included in the temporary propping scheme. Photograph 20 also shows the poor condition of the fire barrier in this location. We would recommend that each junction of the subway is provided with at least 60 minute fire protection but this will be subject to liaison with SaTH's consultant fire safety officer.

Photo 22 - Debris in subway at junction with Pathology and 100mm of ground water

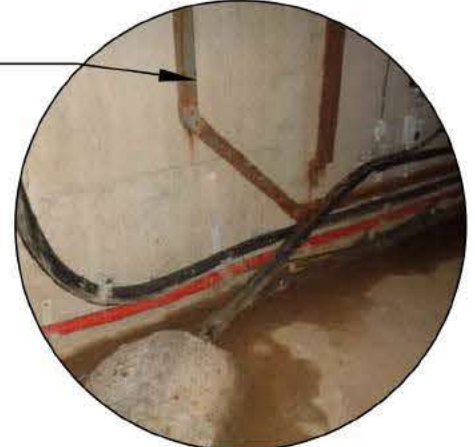
Photo 16 - Mains cables at low level

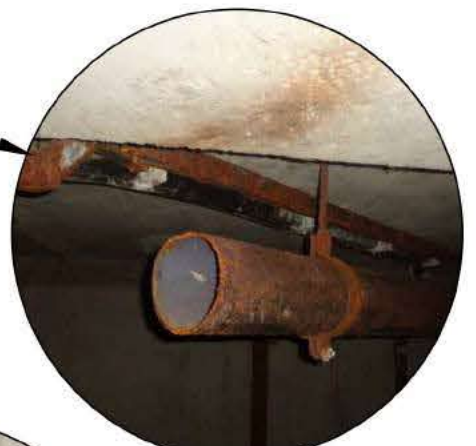
Photo 18 - Redundant steam pipe

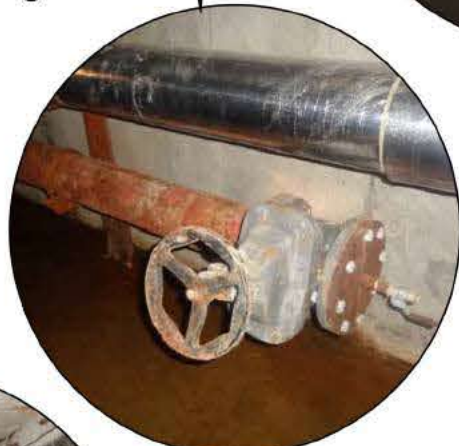
Photo 19 - Redundant gas main (re-routed at high level)

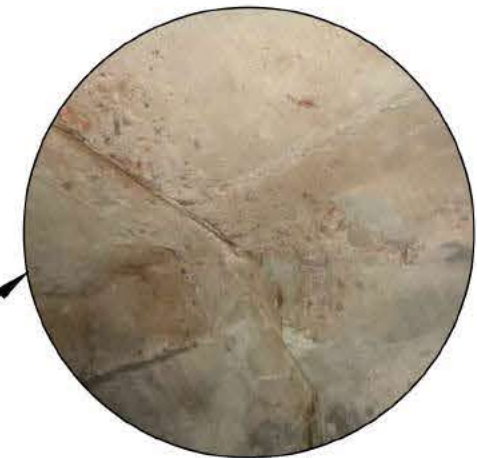
Photo 26 - Localised spalling and leakage to day joint

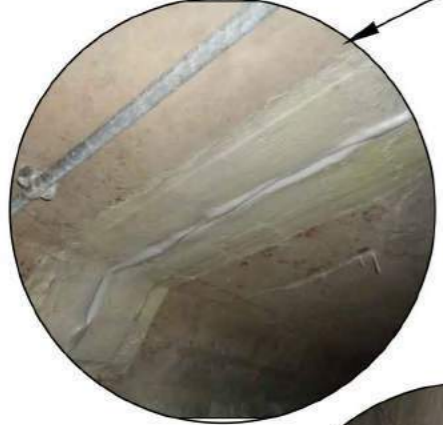
Photo 33 - Localised previous repairs

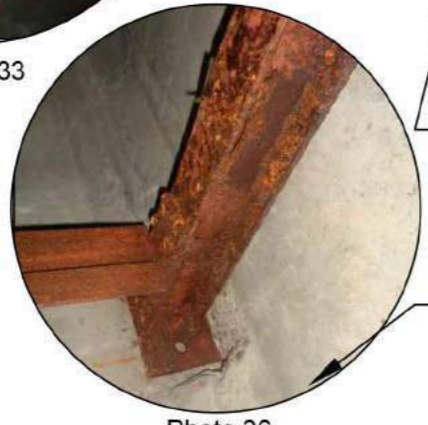
- 2.12 Photographs 27, 29 and 36 in Appendix F show the poor condition of the gas main pipe and the pipework support system. This is in need of immediate repair and ongoing maintenance. This is further demonstrated via photographs 46 and 47 in Appendix G. Photograph 43 of Appendix F also shows a sump pump arrangement which would appear to be in full working order. However, a similar pump is not working in section 3 of the subway, thus, approximately 250mm of standing water is present. This has also been reported to Estates.

Photo 36 - Rusting service support system

- 4.1.5 To prevent potential immediate failure the defective building services support system should be thoroughly overhauled and repaired where isolated defective components should be spliced with galvanised steel, the system should be thoroughly prepared and redecorated throughout. The same applies to the gas main pipe which also requires labelling.

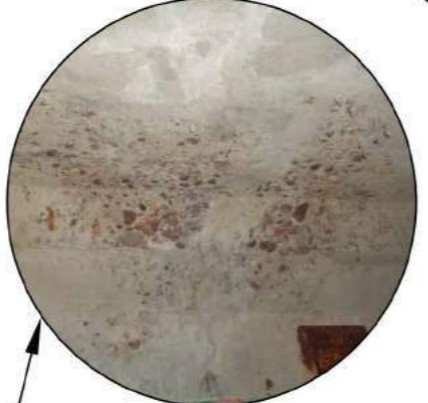
Photo 34 - Localised spalling

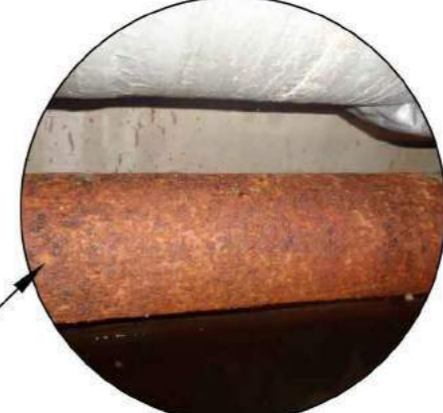
Photo 27 - Poor condition of gas main

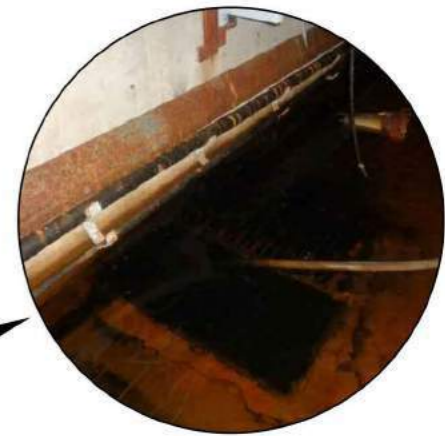
Photo 29 - No sump pump installed (Standing Water)

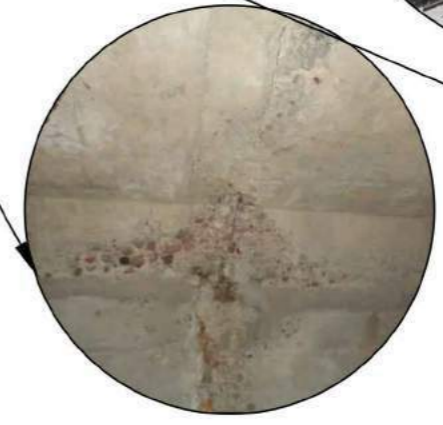
Photo 35 - Localised spalling

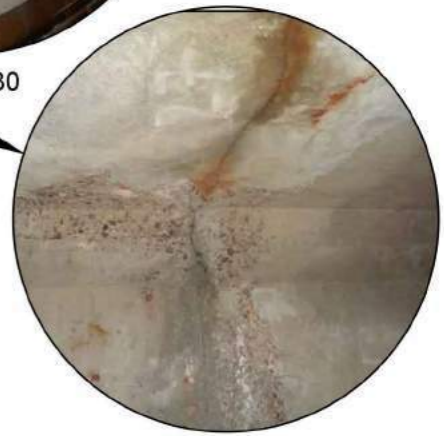
Photo 31 - Localised spalling and leakage to clay joint

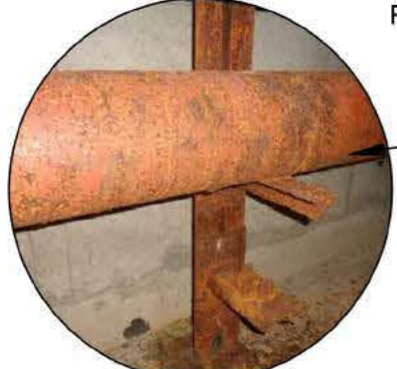
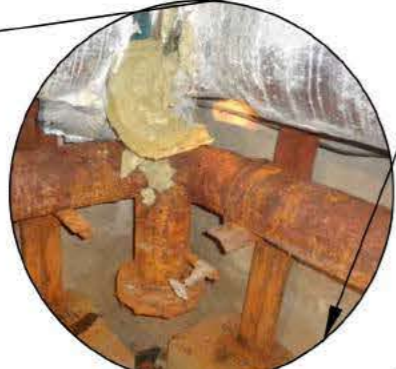
Photo 47 & 48 - Poor condition of gas main and support system

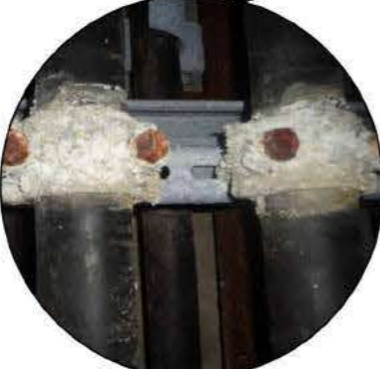
Photo 46 - Calcium build up on service support

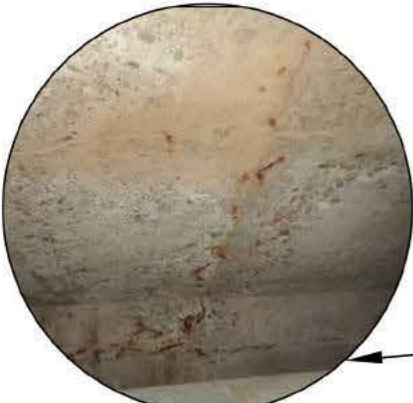
Photo 38 - Localised Spalling

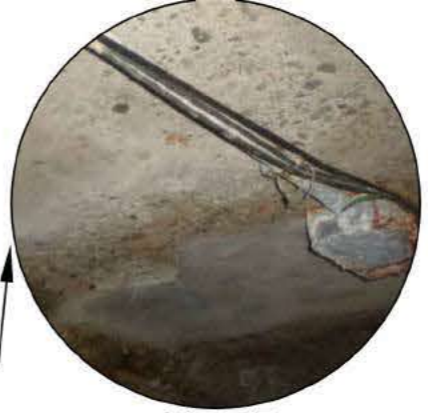
Photo 37 - Localised Spalling

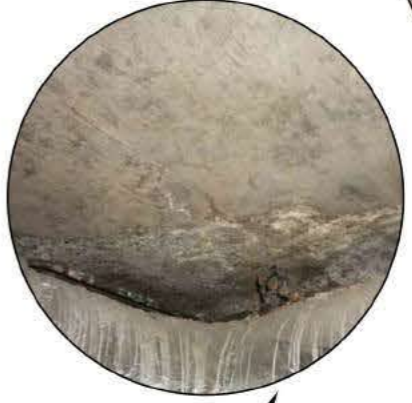
Photo 40 - Localised spalling at junction with subway to maternity

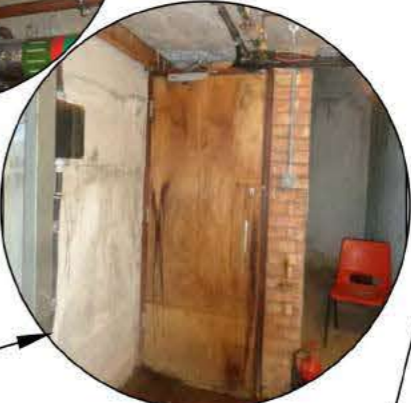
Photo 44 - Poor condition of fire door to Maternity staircase

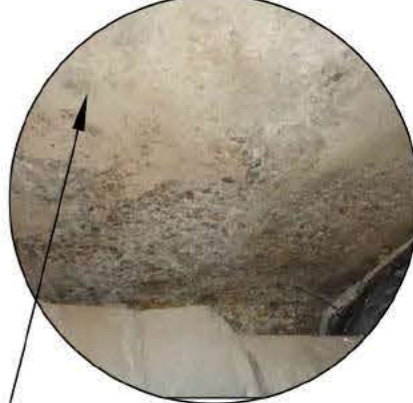
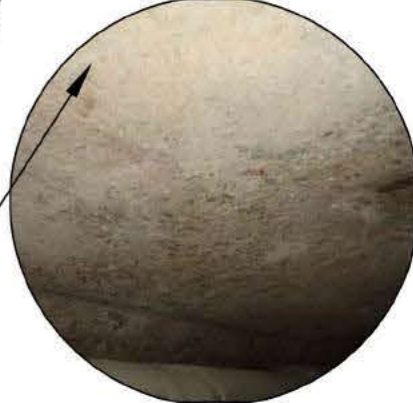
Photo 41 & 42 - Localised spalling at junction with subway to Maternity

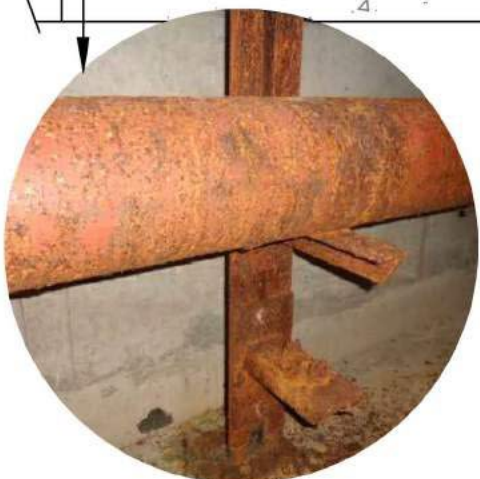
Photo 48 - Poor condition of services support system
